SAFETY ALERT

What lies beneath?

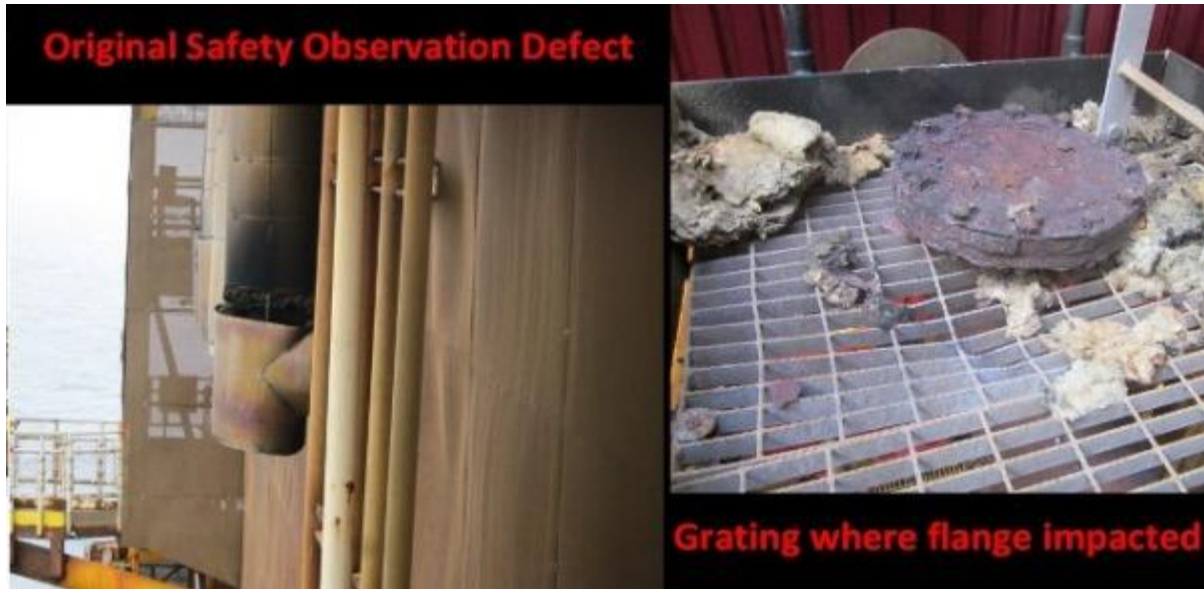
A number of months after the PDO was reported, a member of the crew noticed a lot of insulation and cladding debris on a walkway. Upon further inspection a flange was found on an adjacent access platform grating.

The flange weighed 73.2 kilograms and had dropped 20 metres, the potential consequence based on the DROPS calculator could have been a fatality.

Through the subsequent investigation, the damaged cladding had led to water ingress over time and resulted in severe corrosion under insulation (CUI) to the flange bolts. It was found that all 4 exhausts on this particular stack were originally designed and built using "T" pieced flanges. Had the arrangement drawings been

checked, this PDO threat would have been fully understood and addressed sooner.

When a PDO is identified think of the “What If?” question. What if that falls, could it hit people or plant and what is the worst outcome?

The company pre-task DROPS checklist has been updated to include this question.
